Kingston Brook – Meadow Park, East Leake: Ecological and Physico-chemical Investigation - 2012

This report details an ecological and habitat survey conducted on the Kingston Brook, Meadow Park, East Leake on 21 September 2012. The following features of the Kingston Brook were investigated at 4 sites as shown in Figure 1:

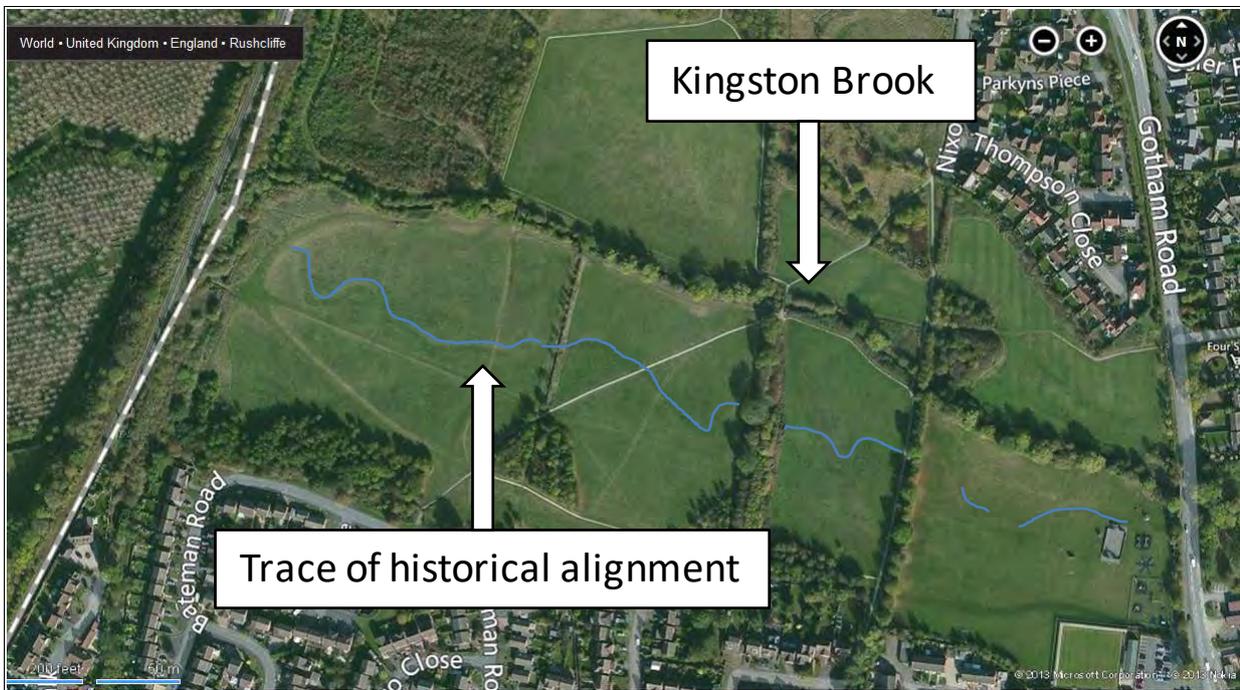
The entire length of the Kingston Brook through Meadow Park has been extensively re-sectioned as a result of historical full channel realignment and maintenance activities which have aimed to improve land drainage, flow conveyance and reduce flood risk in the wider catchment. This has resulted in the creation of a relatively straight planform, with a much wider and deeper channel than would naturally occur for the gradient and flow of the stream. Recent aerial photographs identify the position of a relic channel in the floodplain which exhibits a much more meandering planform than the present day alignment (Figure 2). Dating the realignment is problematic due to the availability of historical mapping for the area. However, the Kingston Brook is shown in its current position through Meadow Park in the 1798 Enclosure Map. The relic channel shown in Figure 2 was therefore bypassed over 200 years ago through the creation of the current channel. This was probably done for land drainage purposes which might have been implemented as early as the 1600s.

Figure 2. Aerial photograph showing current and historical alignment of the Kingston Brook through Meadow park

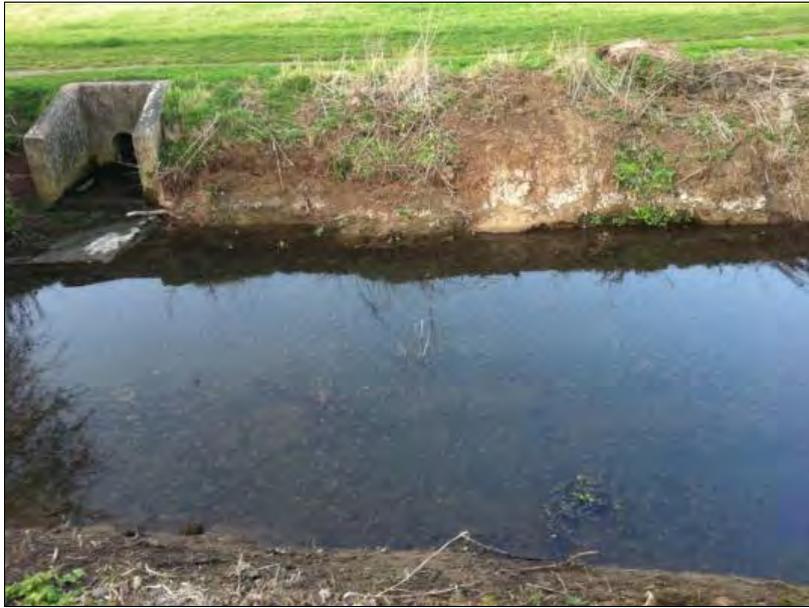
Plate A-1: Further over-widening of channel between sites 2 and 3, combined with bed lowering has resulted in almost no flow velocity (March 2012)

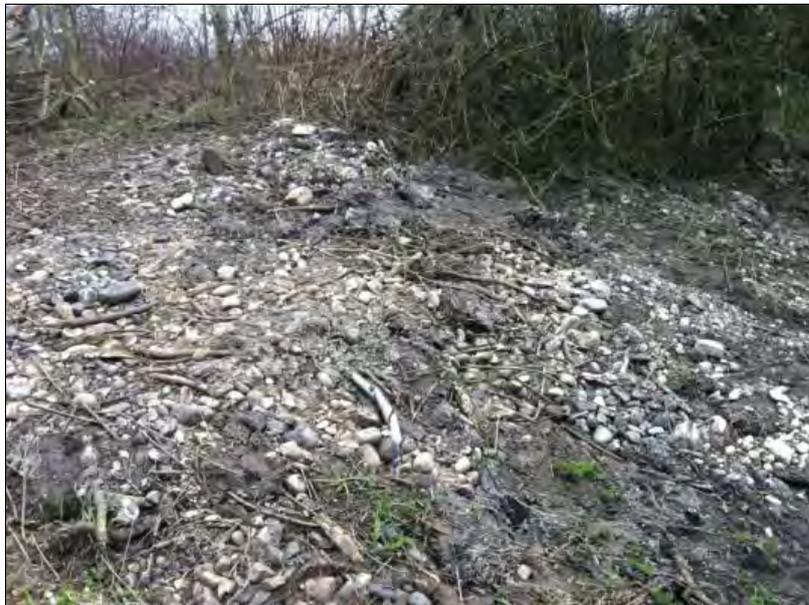
The dredging and removal of coarse substrates from riffle habitats in the Kingston Brook (see Appendix A, Plate A-2) is perhaps the best example of inappropriate maintenance working by the IDB. Identified as providing a valuable habitat for aquatic macro-invertebrates (and also utilised by fish for spawning) riffle removal is significantly damaging within the context of the current condition of the Kingston Brook. Due to the scarcity of coarse substrates within the system this will be a permanent habitat loss unless replaced as a component of a restoration scheme. It should be noted that the removal of coarse substrate goes against the IDB's own maintenance guidance (Buisson *et al.*, 2008).

Plate A-2: Clear evidence of bed dredging downstream of Site 5. Removal of gravel and cobble reduces in-channel habitat diversity and limits ecological potential (March 2012)

- Due to the high levels of historical disturbance along Kingston Brook it is very unlikely that natural geomorphological processes will be able to fully restore appropriate form and function along the Kingston Brook through Meadow Park. For example, the stream will not be able to naturally recover the coarse sediment removed from riffle habitats which was dumped on the banks.

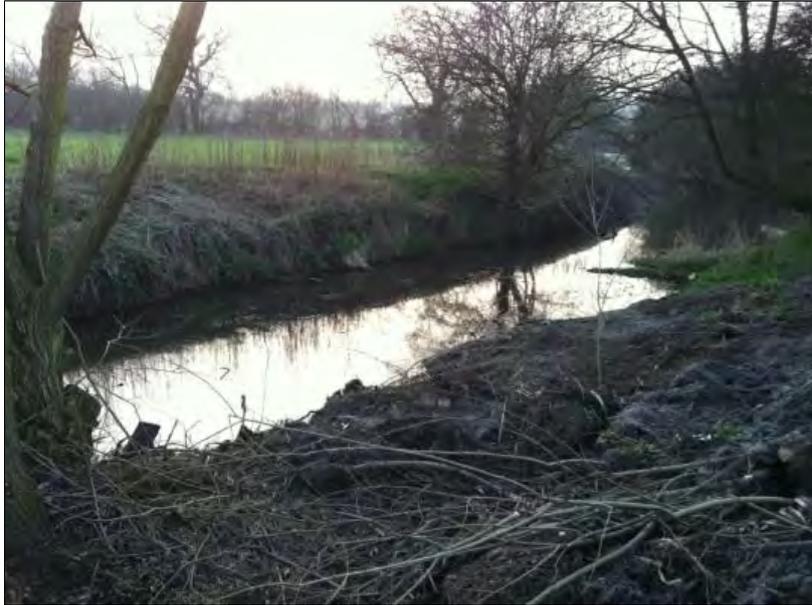
grubbing out of trees (see Appendix A, Plate A-3) has locally reduced bank stability and will potentially lead to bank failure and fine sediment ingress, all of which are harmful to the ecology of the stream.

Plate A-3: Tree clearance and dredging deposits in Meadow Park (March 2012)

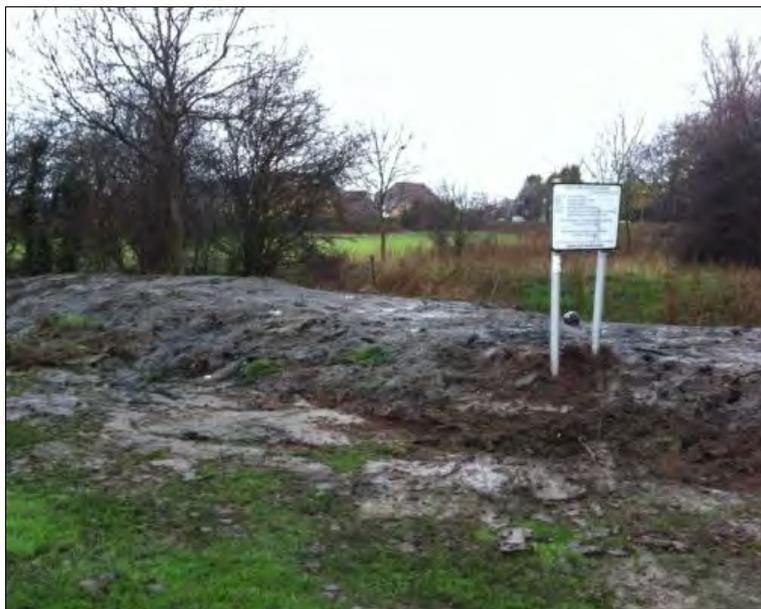
Plate A-4: Spoil deposits upstream of Meadow Park indicate levels of fine sediment accumulation in Kingston Brook. Rank vegetation often develops and can obscure views of the stream (March 2012)

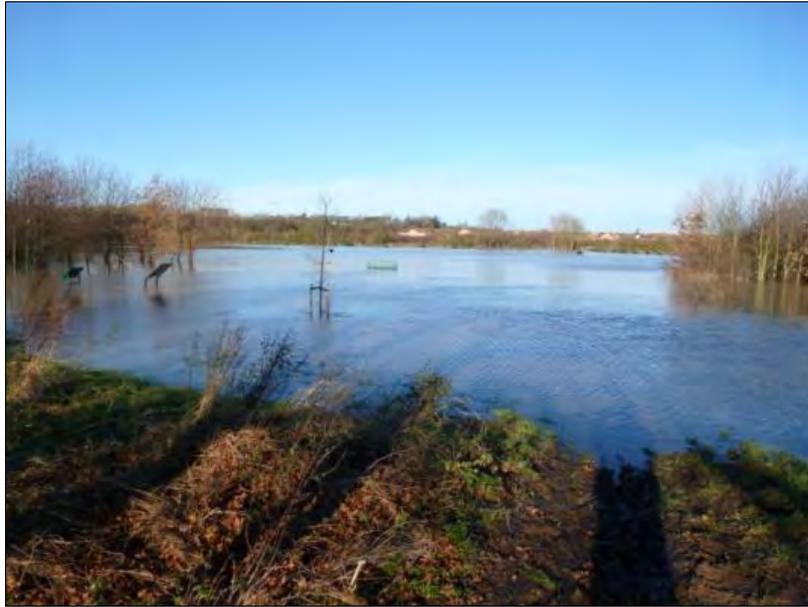
Plate A-5: Flooding in Meadow Park (November 2012) (photograph by Vicenta Rose, reproduced with kind permission)
